Analysis Tool Manual

V2.0

This software is specially adapted to the CRY26XX Handheld Acoustic Imager to view and analyze data from pictures and videos taken by the imager, and to edit and output the corresponding test reports. It is only available for Windows.

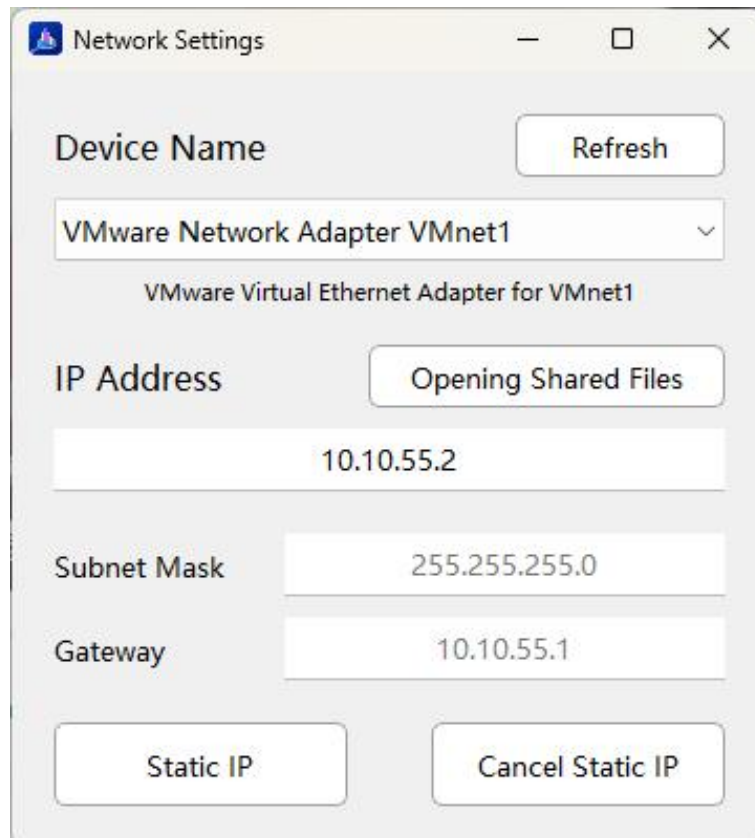
- **Refresh**: retrieve and get the list of computer NIC names (when there are NIC changes, you need to manually click the refresh button)
- **IP Address**: to be set the static IP address of the NIC (10.10.55.xxx, except 10.10.55.55)
- **Opening Shared Files**: when the computer is successfully connected to the equipment, open the TF card storage path of the sound camera (the CRY26XX needs to be inserted with a TF card)
- **Subnet Mark**: Default, cannot be changed.
- **Gateway**: adapted, cannot be changed
- **Static IP**: applies the "IP address" to the currently selected network card

- **Cancel Static IP:** cancel the static IP of the currently selected NIC and set it to a dynamically obtained IP address.

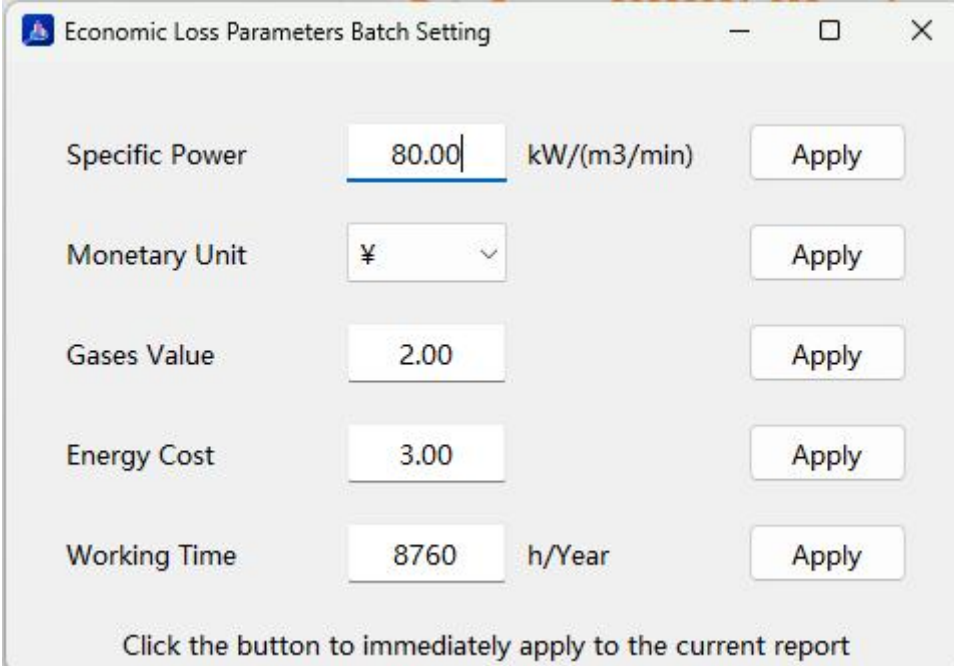
Parameter	Value	Unit	Action
Specific Power	80.00	kW/(m3/min)	Apply
Monetary Unit	¥		Apply
Gases Value	2.00		Apply
Energy Cost	3.00		Apply
Working Time	8760	h/Year	Apply

Economic loss parameter setting interface

The parameters are adapted to the functional parameters in the CRY26XX;

- **Apply:** Apply the corresponding parameters to all selected test points in the current gas report and any future added test points (if the test points do not have default parameters). Only change the currency unit symbol without performing currency conversion.

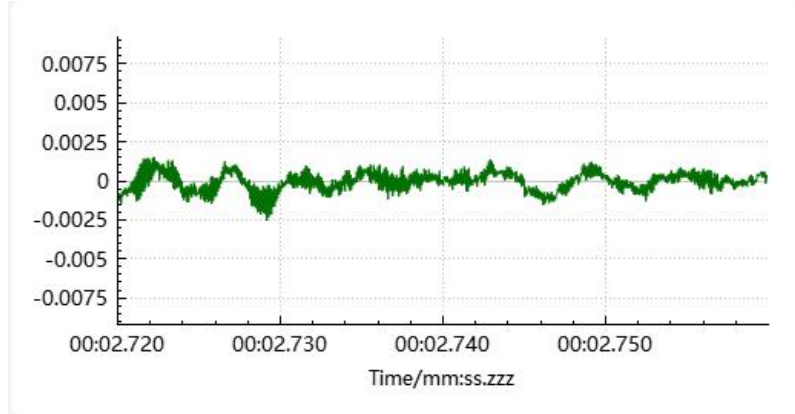
Time-domain waveform curve of the image frame

Draws the time-domain waveform graph of the audio data for the current image frame. If there is no audio data or it cannot be read, it will display a blank space.

If the file contains audio data, clicking on the waveform area will display a time-domain waveform interface consisting of a time-domain waveform, spectrum graph, and spectrogram.

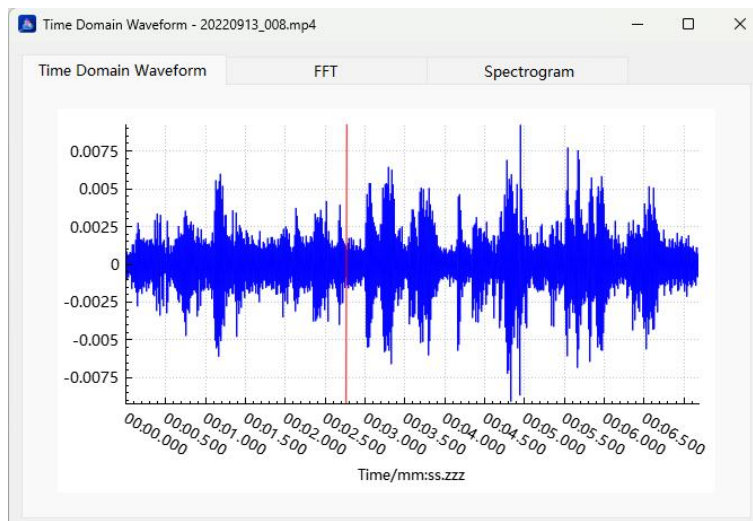
Including the entire audio data, the red vertical line indicates the current position of video playback.

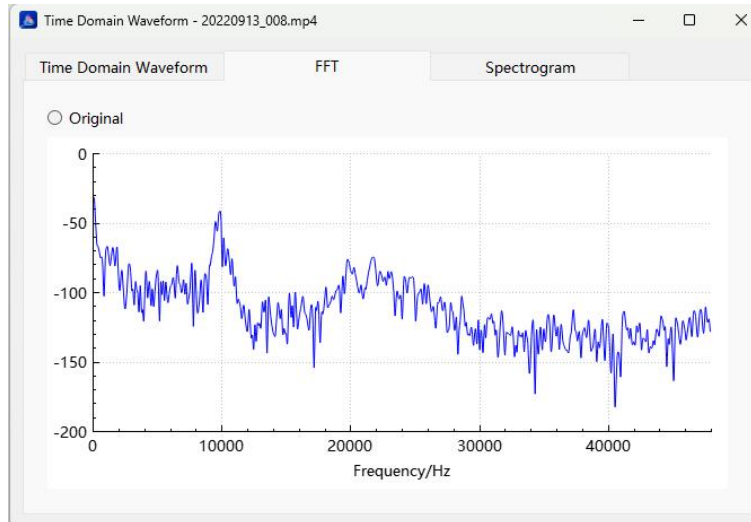
It includes the audio data of the current image frame. The vertical axis can be switched between displaying dB values and raw values by selecting or deselecting the "Raw Value" radio button.

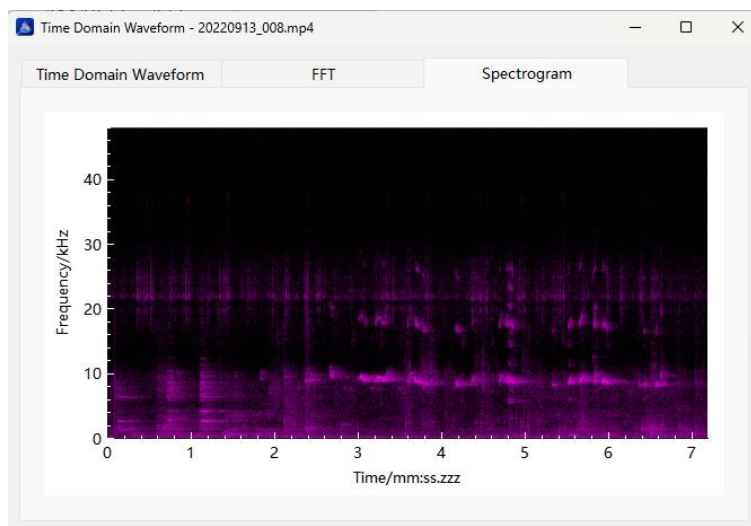
Including the entire audio data.

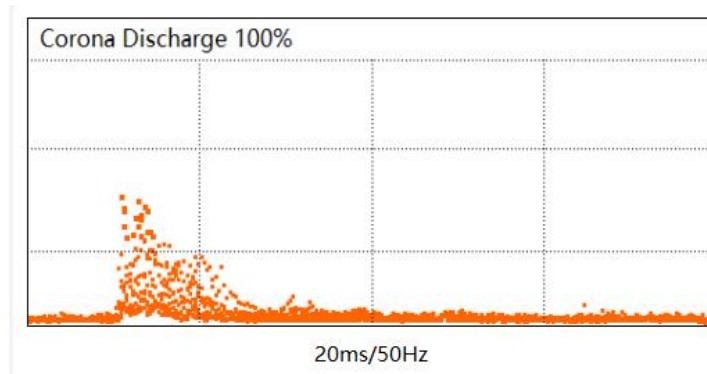
PRPD (Partial Discharge Pattern) spectrum and discharge type display

Analyze the audio data and plot the PRPD (Partial Discharge Pattern) spectrum in conjunction with the pddtemp.txt file. Display the PRPD spectrum, discharge type, and synchronization frequency corresponding to the current image frame. If there is no audio data, it will be displayed as blank.

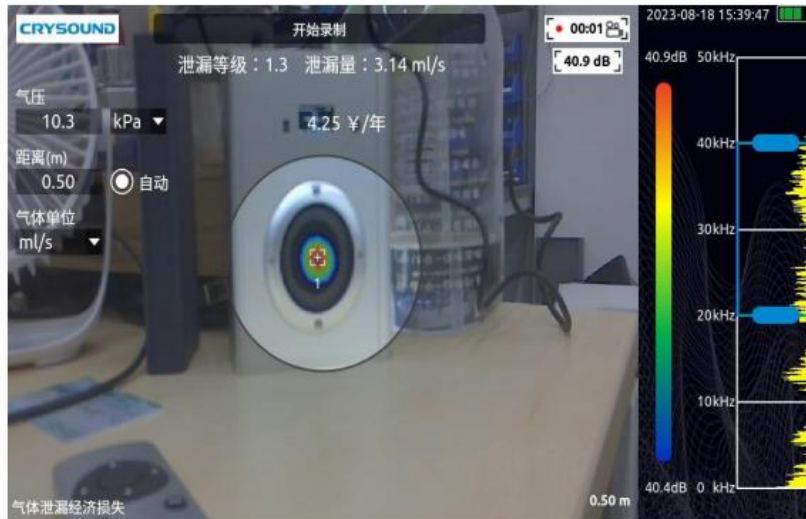
20230818_001.mp4		
Test Point Information		
Fault Site	Gas Type	Fault Level
Fault Site	Air	Minor Defect
Site Description	Description	
Max SPL	Air Pressure	Maintenance Advice
40.9 dB	0.0103 MPa	can be ignored
Detailed Calculation of Economic Loss (/year)	Gas Leak Grade	Gas Leakage Flow (work condition ml/s)
4.25 ¥	1.3	3.14
Electricity Consumption (kWh)	Carbon Emission (kg/Year)	
10.74	3.96

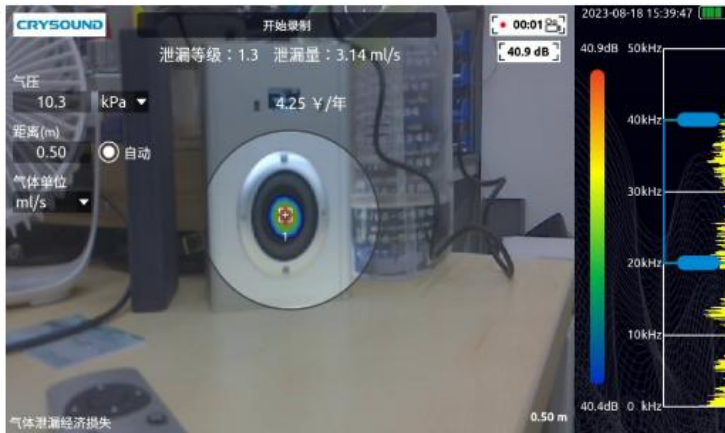
Maintenance Advice:
can be ignored

Properties	
Point ID	1
Detect Point Name	20230818_001
Gas Type	Air
Point Max SPL	40.9 dB
Fault Site	Fault Site
Site Description	Site Description
Test Distance	0.5 m
Loss Vol	3.14 ml/s
Economic Loss	4.25 ¥/Year
Electricity Consumption	10.74 kWh
Carbon Emissions	3.96 kg/Year
Fault Level	Minor Defects
